Debris/Ice/TPS Assessment And Integrated Photographic Analysis For Shuttle Mission STS-46

September 1992

Gregory N. Katnik
NASA/Kennedy Space Center

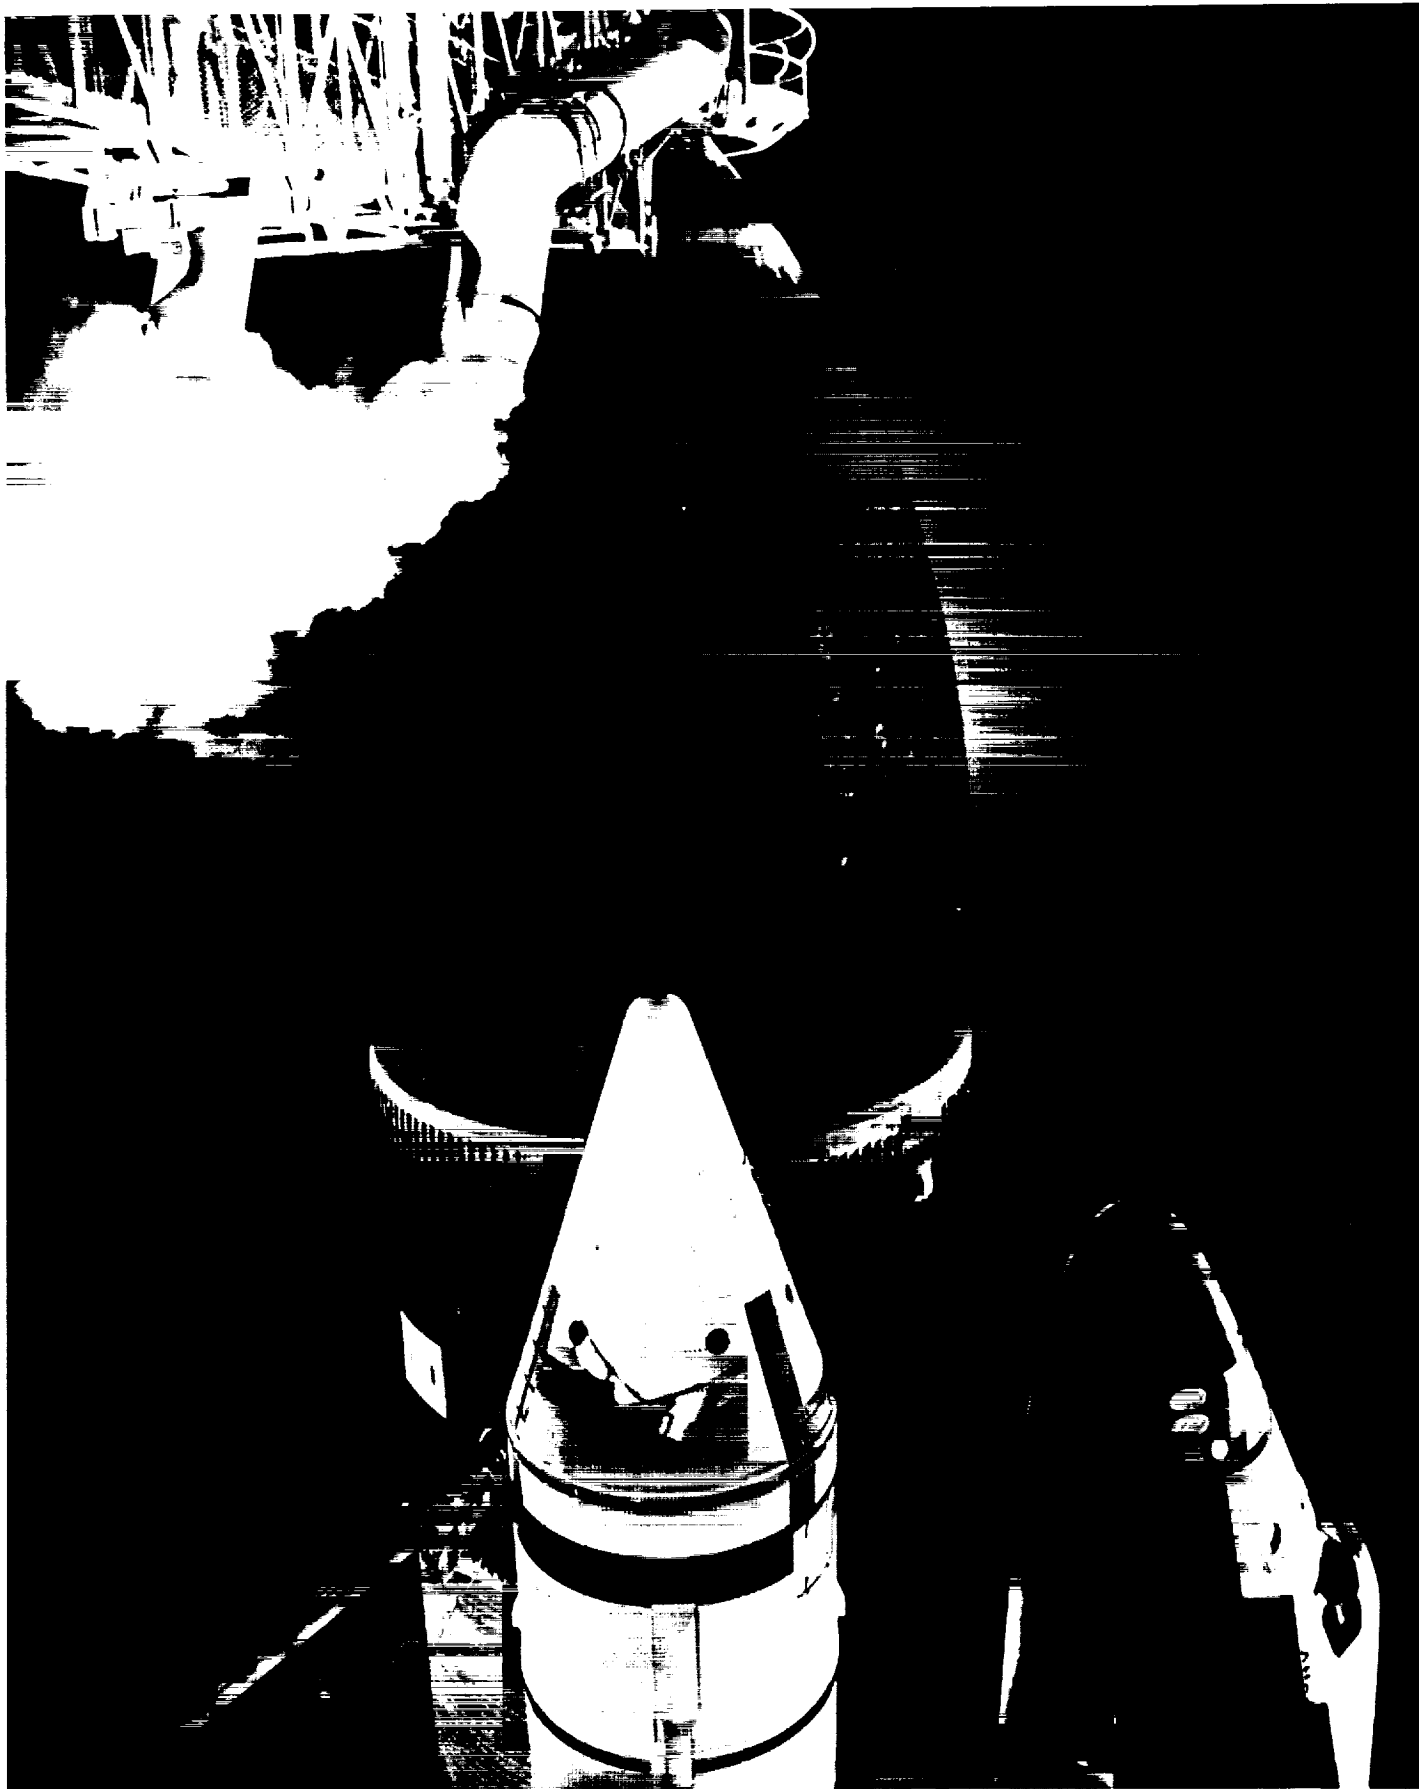
There was no ice/frost accumulation and light condensate on the LO2 tank ogive and barrel sections. There were no TPS anomalies. The tumble valve cover was intact. The pressurization line and support ramps were in nominal configuration. The STI measured surface temperatures that averaged 75 degrees F on the ogive and 73 degrees Fahrenheit on the barrel section. In comparison, the Cyclops radiometer measured temperatures that averaged 73 degrees F on the ogive and 69 degrees F on the barrel; SURFICE predicted temperatures of 66 degrees F on the ogive and 61 degrees F on the barrel.

Light condensate, but no ice or frost accumulation, was present on the ET LO2 tank ogive and barrel section TPS acreage

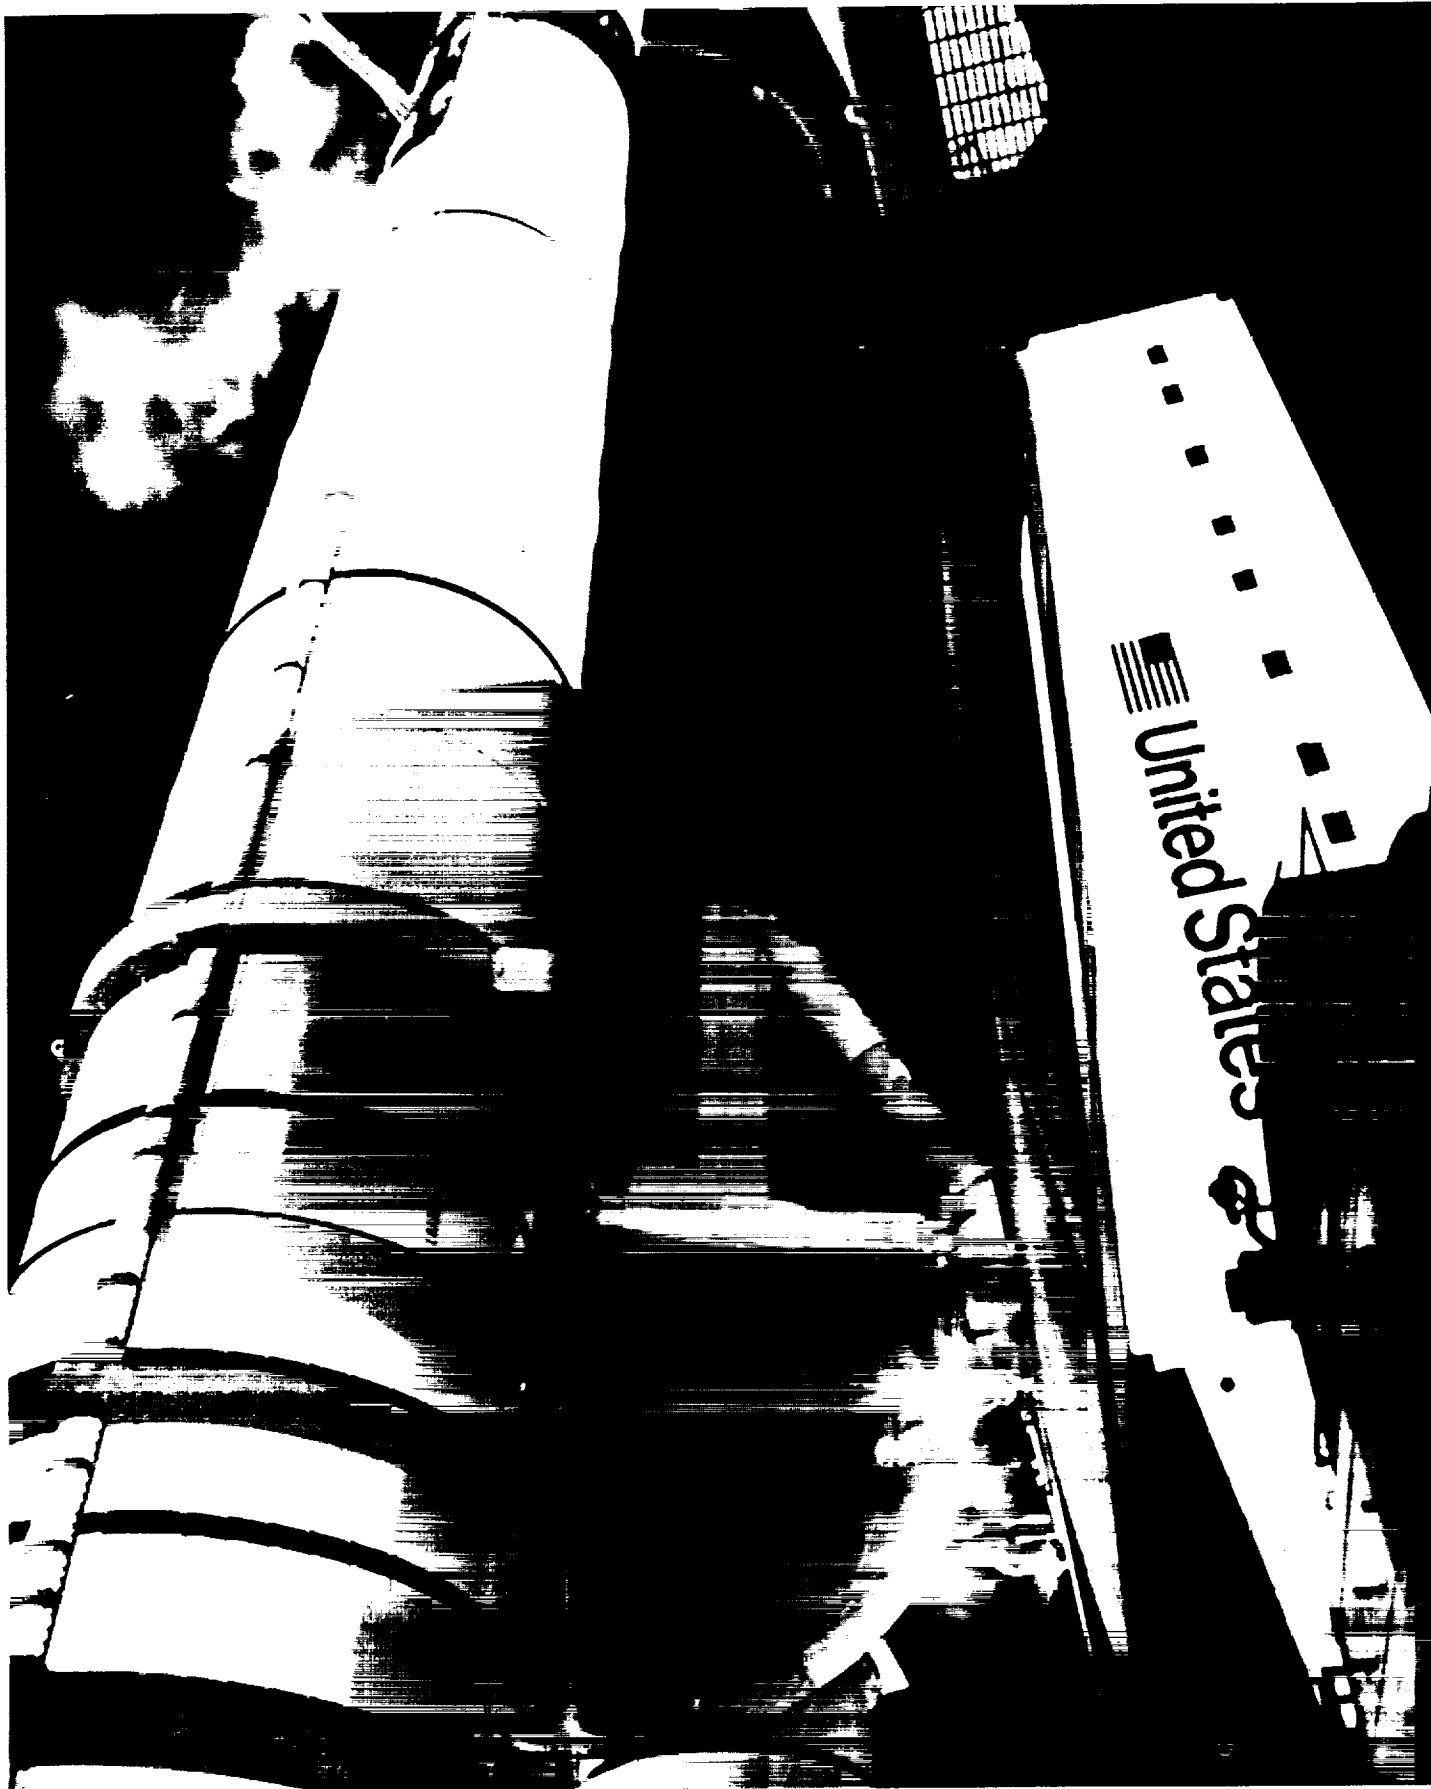
There were no LH2 tank TPS acreage anomalies. Light condensate, but no ice or frost, was present on the acreage and aft dome. The portable STI measured surface temperatures that averaged 68 degrees F on the upper LH2 tank and 67 degrees F on the lower LH2 tank. In comparison, the Cyclops radiometer measured temperatures that averaged 67 degrees F on the upper LH2 tank and 68 degrees F on the lower LH2 tank; SURFICE predicted temperatures of 54 degrees F on the upper LH2 tank and 67 degrees F on the lower LH2 tank.

Light condensate, but no ice or frost accumulation, was present on the LH2 tank and aft dome TPS acreage

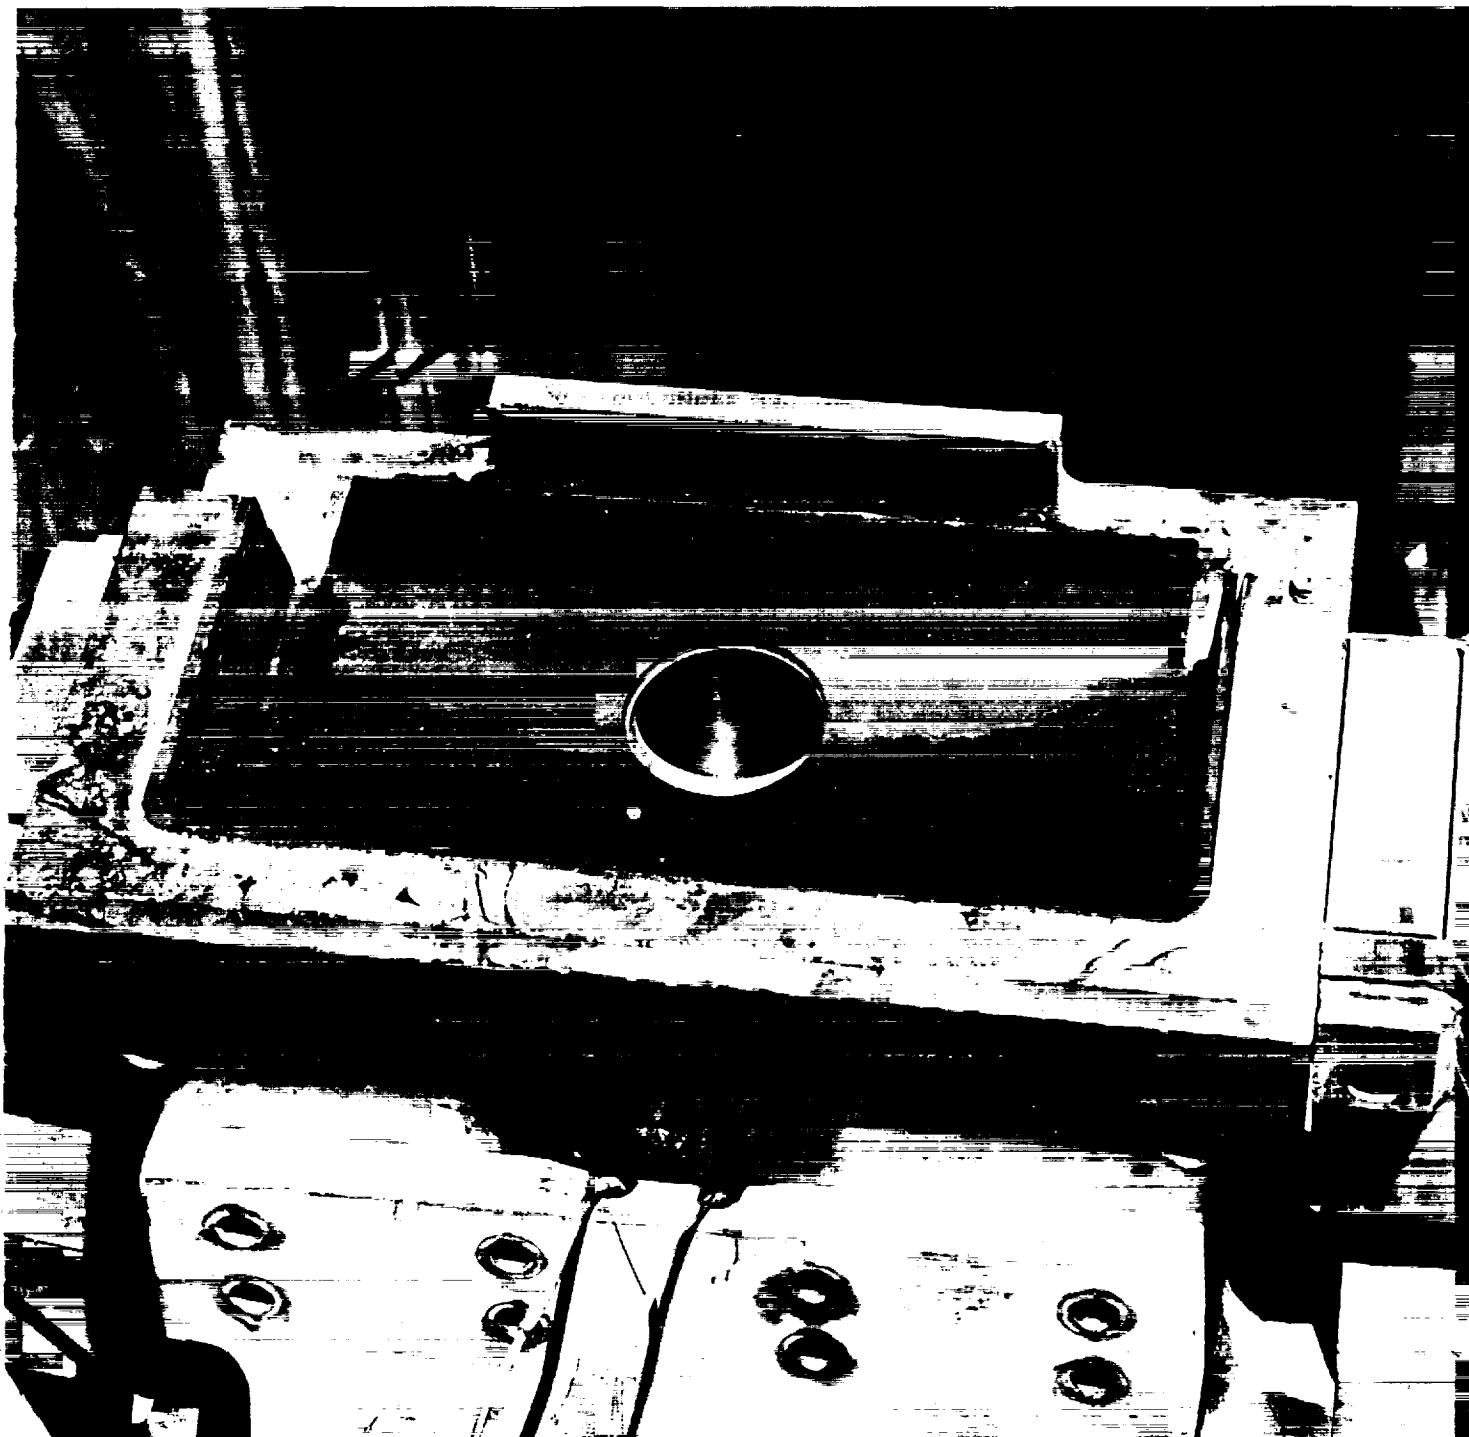
EPON shim material was intact on all south holddown posts. However, the sidewall material was partially debonded on HDP #1 and #5. There was no visual indication of a stud hang-up on any of the south holddown posts. No ordnance fragments were found in the south HDP stud holes. All of the north HDP doghouse blast covers were in the closed position and exhibited less than normal erosion. The SRB aft skirt purge lines were in place but slightly damaged. The SRB T-0 umbilicals exhibited minor damage including deformation of the sacrificial connector savers.

Plume erosion of the south SRB holddown posts was typical. EPON shim material was intact, but debonded along the sidewalls.

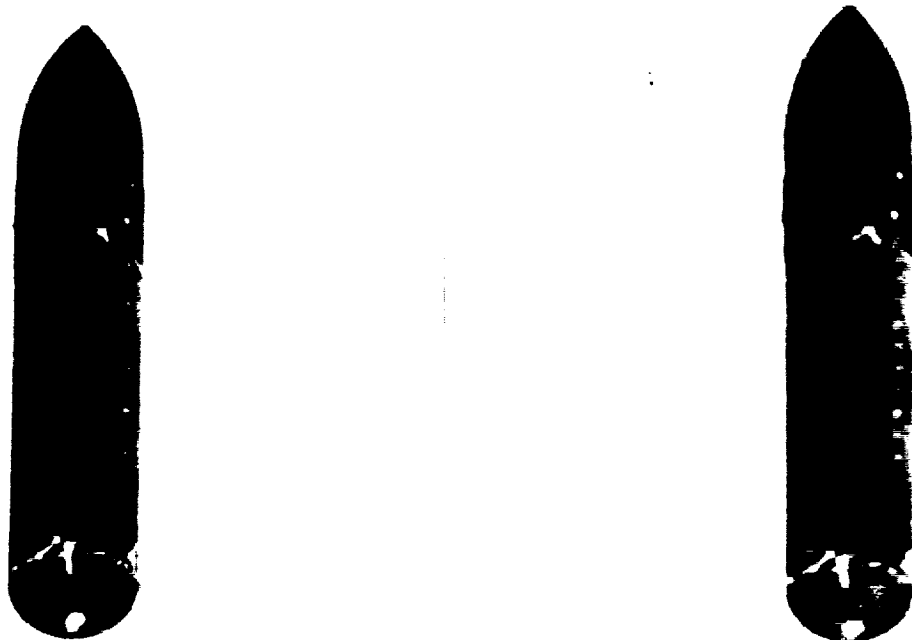
Views of the External Tank 12 minutes after separation from the Orbiter showed no anomalies on the LO2 tank, intertank, LH2 tank, and aft dome TPS acreage. Bright spots on the PAL ramp, bipods, pressurization line/cable tray ramps, EO fitting, and LH vertical strut were caused by reflected sunlight.

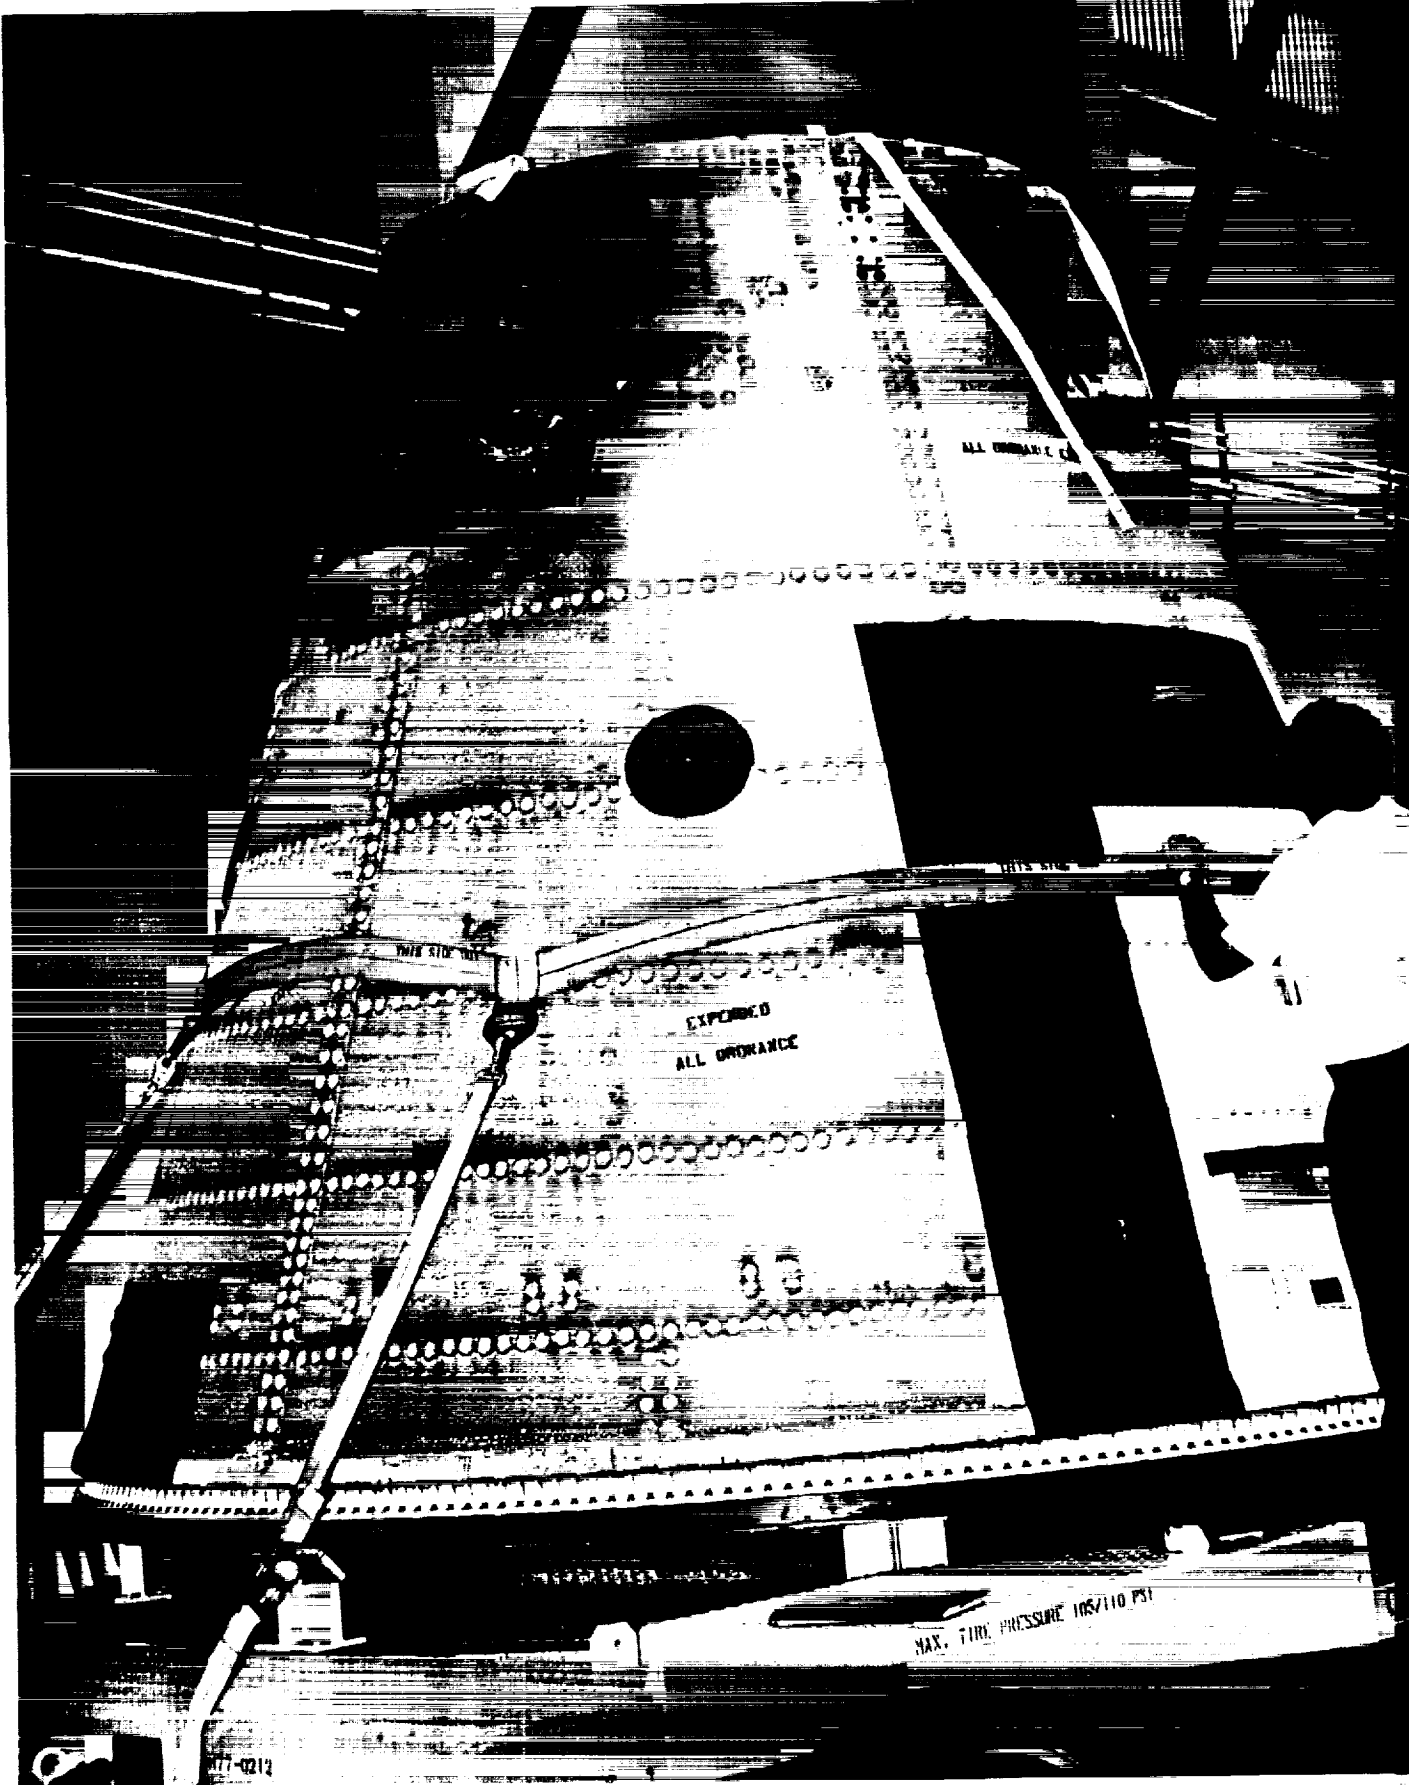
The RH frustum had 10 MSA-2 debonds over fasteners and one area of missing TPS near the 381 ring frame between the +Y and +Z axes. All BSM aero heat shield covers were locked in the fully opened position.

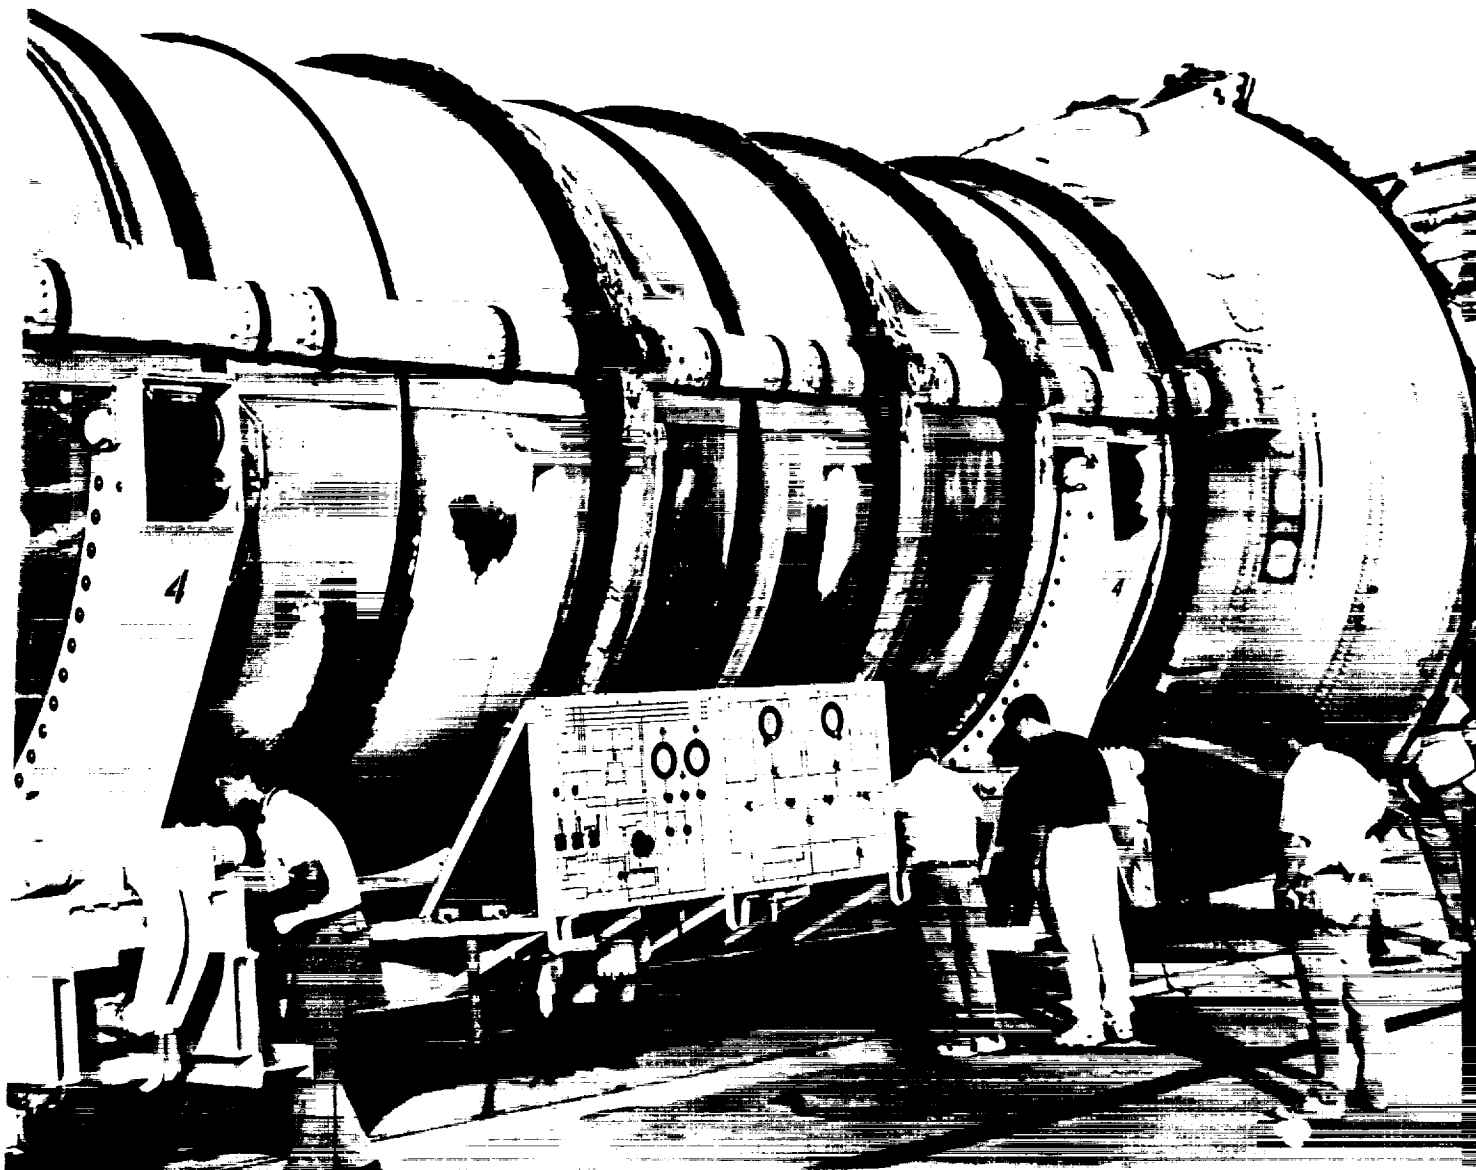
Post flight condition of the RH aft booster. The aft skirt acreage TPS was sooted but in good condition. The ET/SRB aft struts, ETA ring, and IEA appeared undamaged. All three aft booster stiffener rings sustained water impact damage.

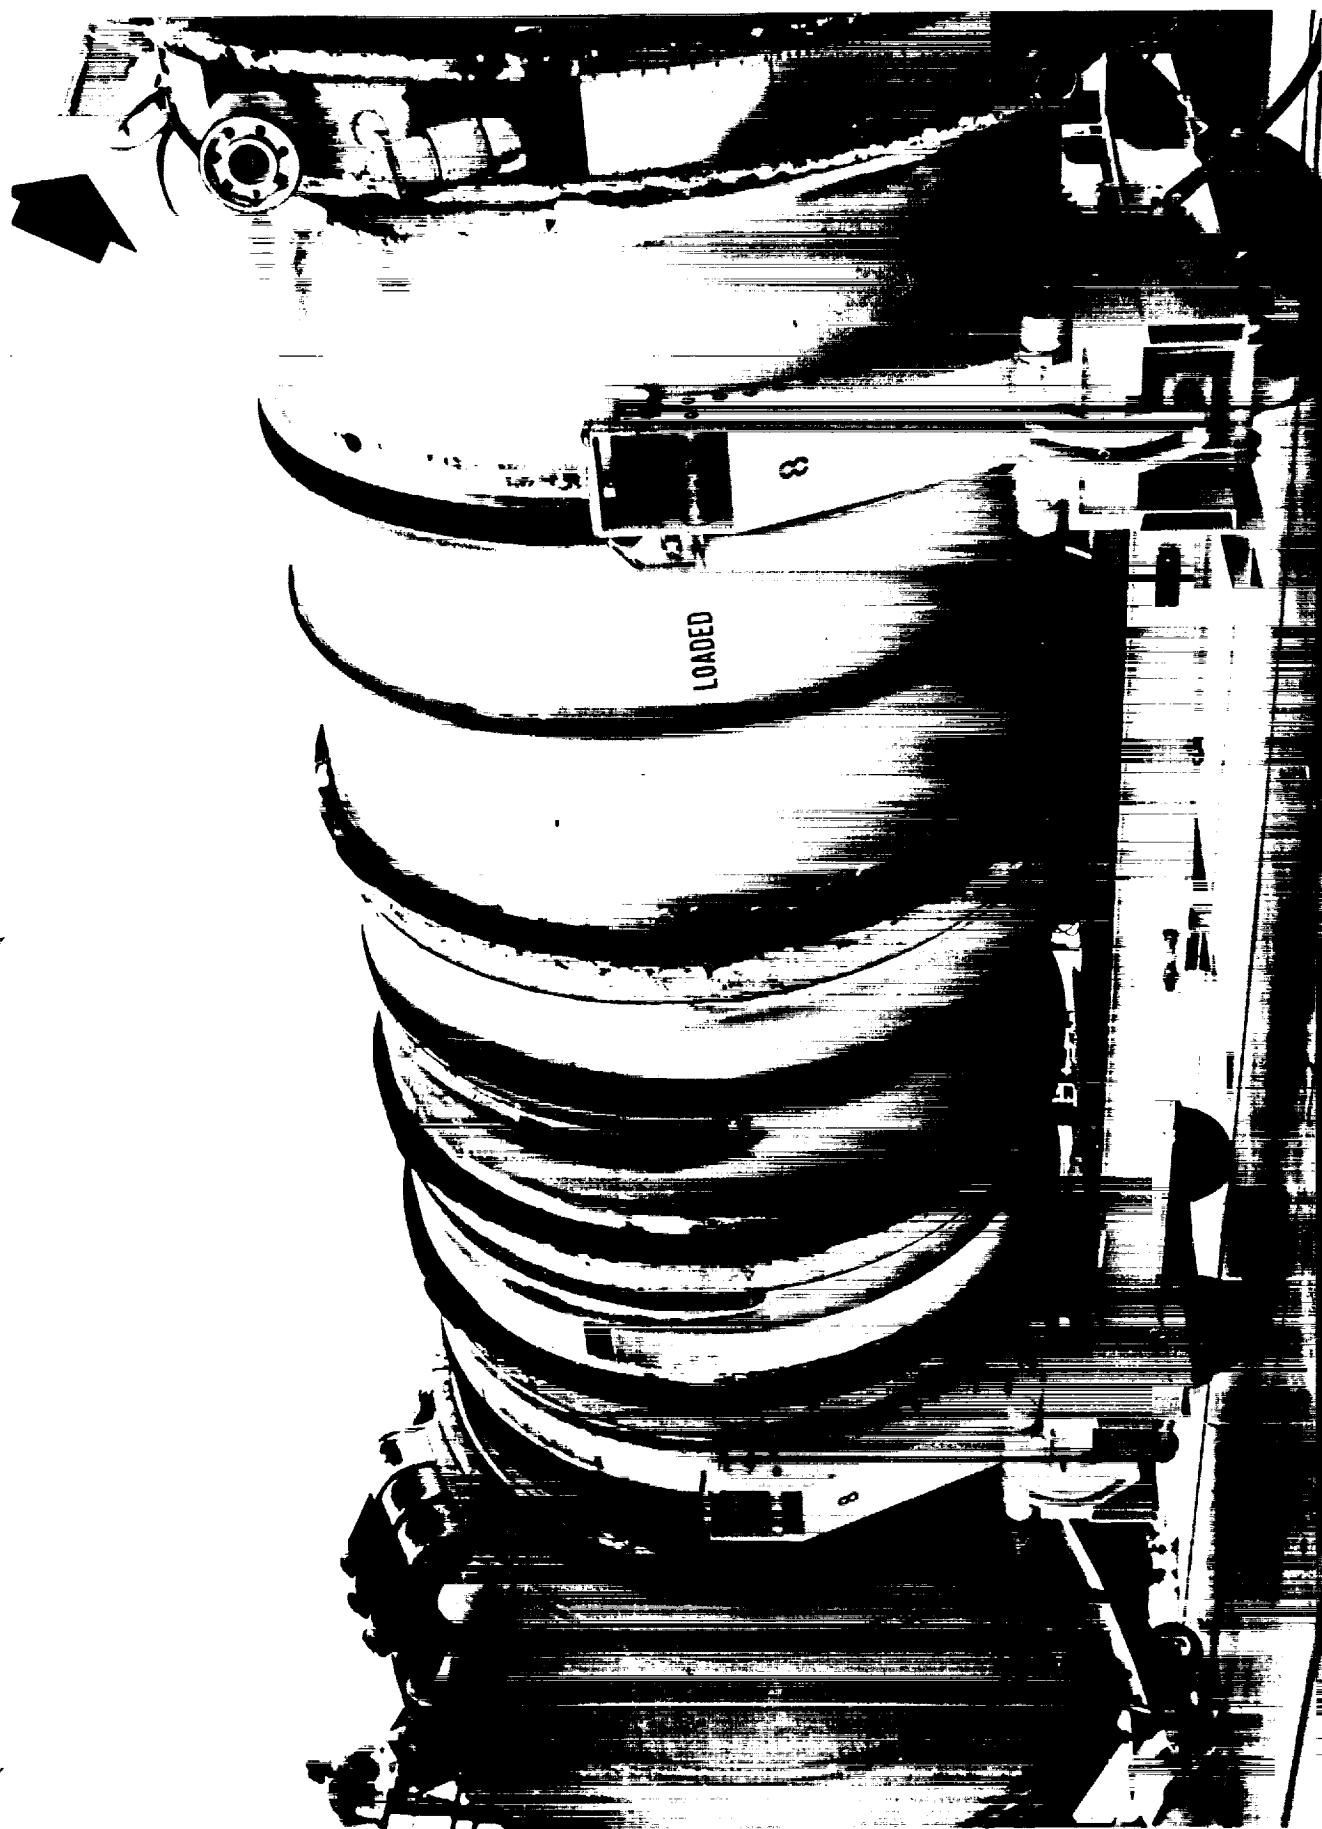
Post flight condition of the LH aft booster. The aft skirt acreage TPS was sooted but in good condition. Note water impact damage to the ETA ring and IEA.

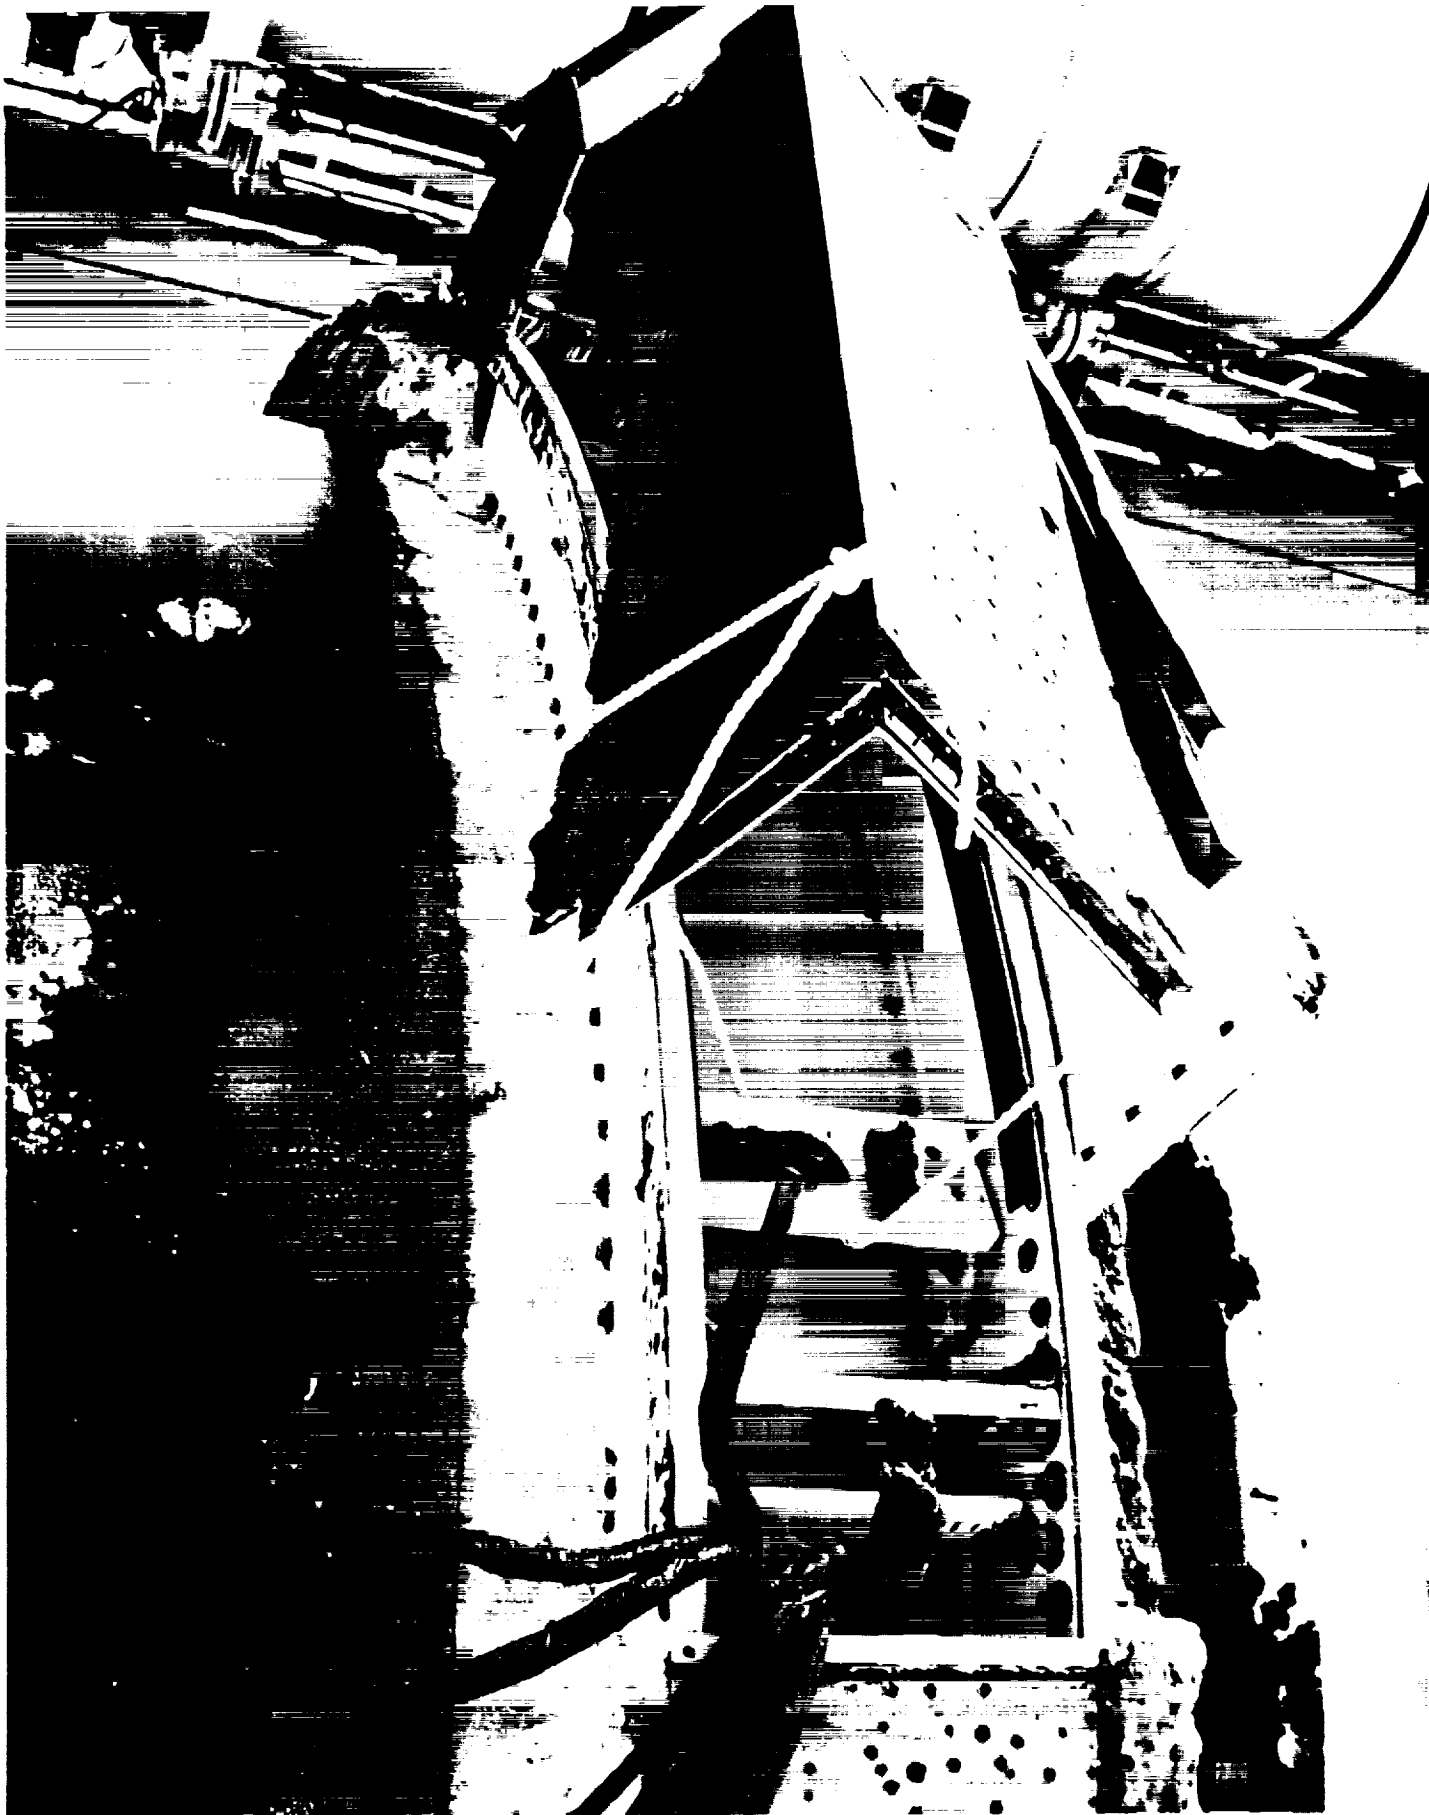
Close-in view of water impact damage to the ETA ring, IEA, and IEA covers. This type of damage was not a debris concern.

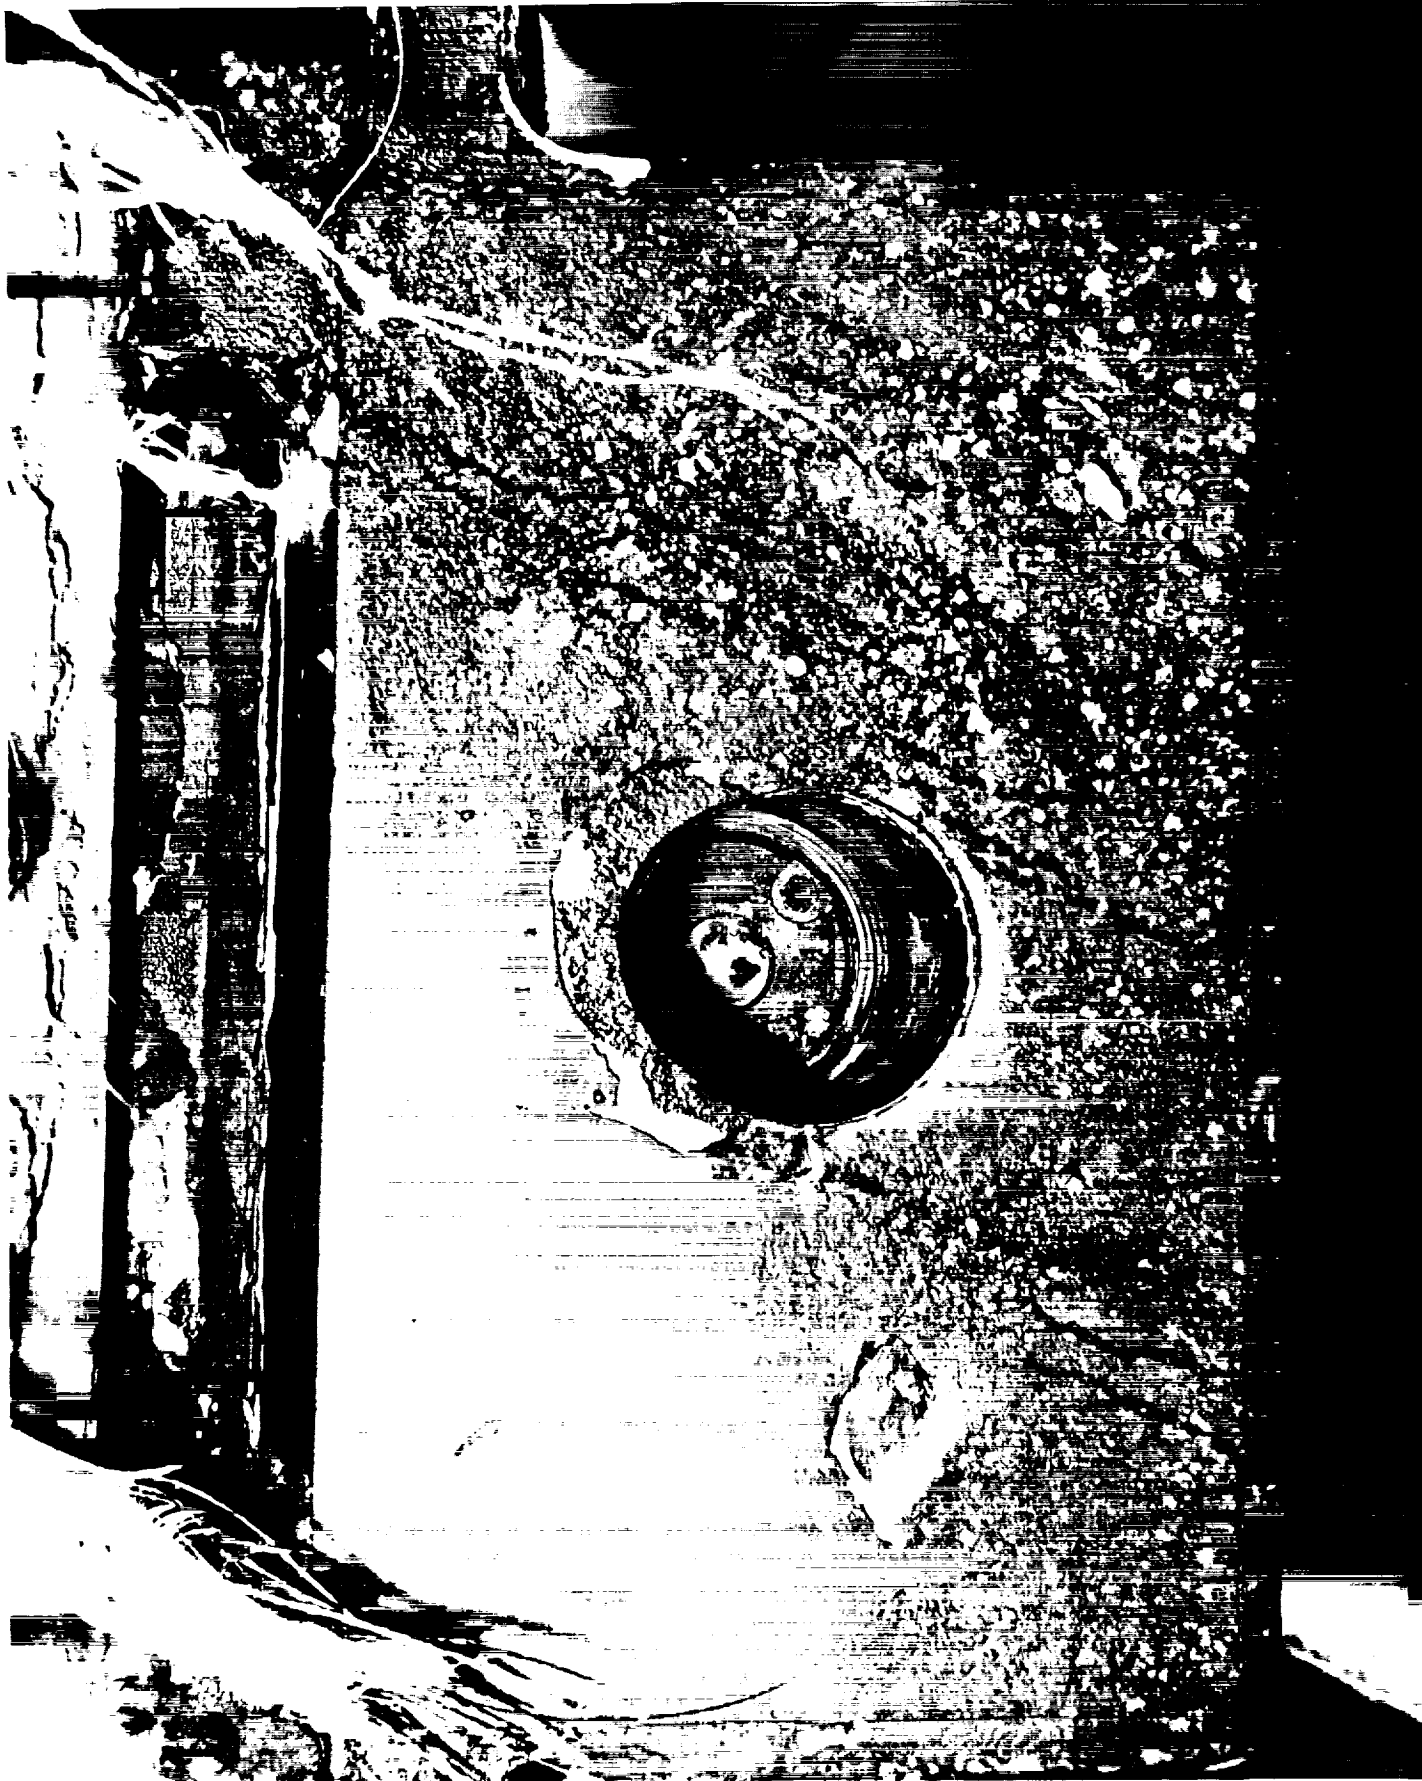
The HDP #7 stud hole was broached due to a stud hang-up at lift off. Small pieces of the EPON shim material adjacent to the stud hole had been pulled off by the stud.
